**CITY OF WEST LINN**  
**PRE-APPLICATION CONFERENCE MEETING**  
**SUMMARY NOTES**  
**September 15, 2022**

**SUBJECT:** Flood Management Area Development Permit and Willamette River Protection Area Permit at 3801 Calaroga Dr.

**FILE:** PA-22-26

# Endres Residence Porch Addition

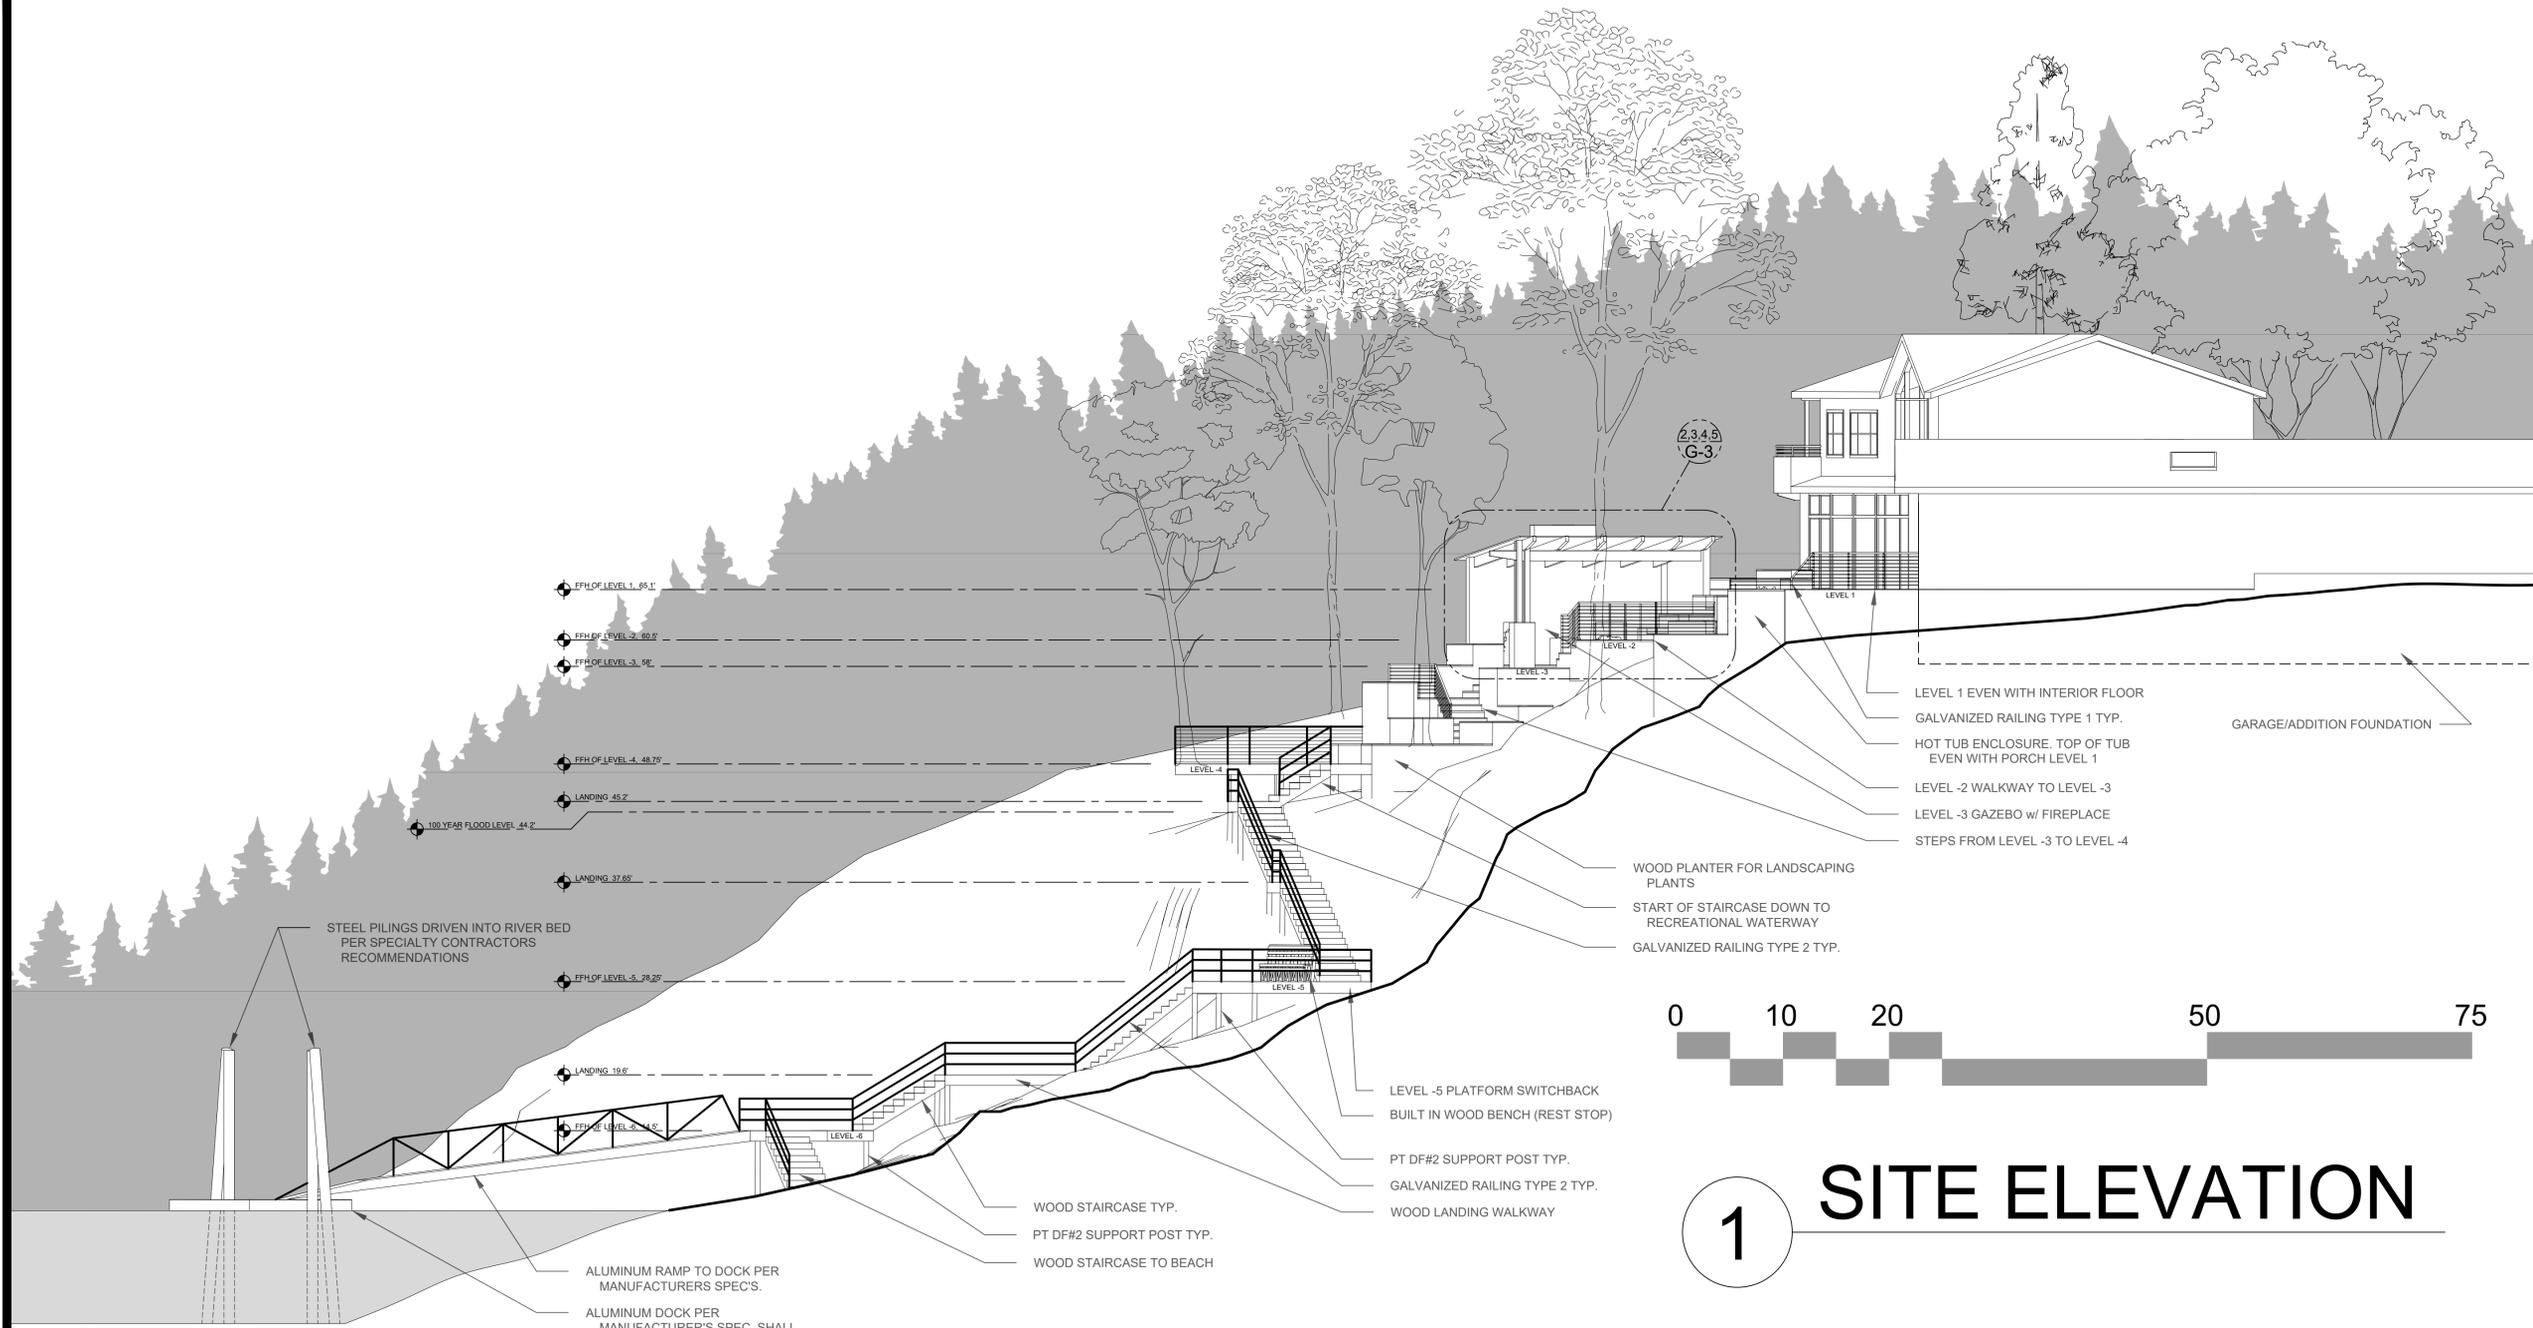
# 1 SITE ELEVATION

**FLOOD PLAIN NOTE:**  
 100 YEAR FLOOD PLAIN ELEVATION = 44.2 FEET  
 FLOOD INSURANCE RATE MAP NO. 41005C0019D  
 EFFECTIVE DATE : JUNE 17, 2008

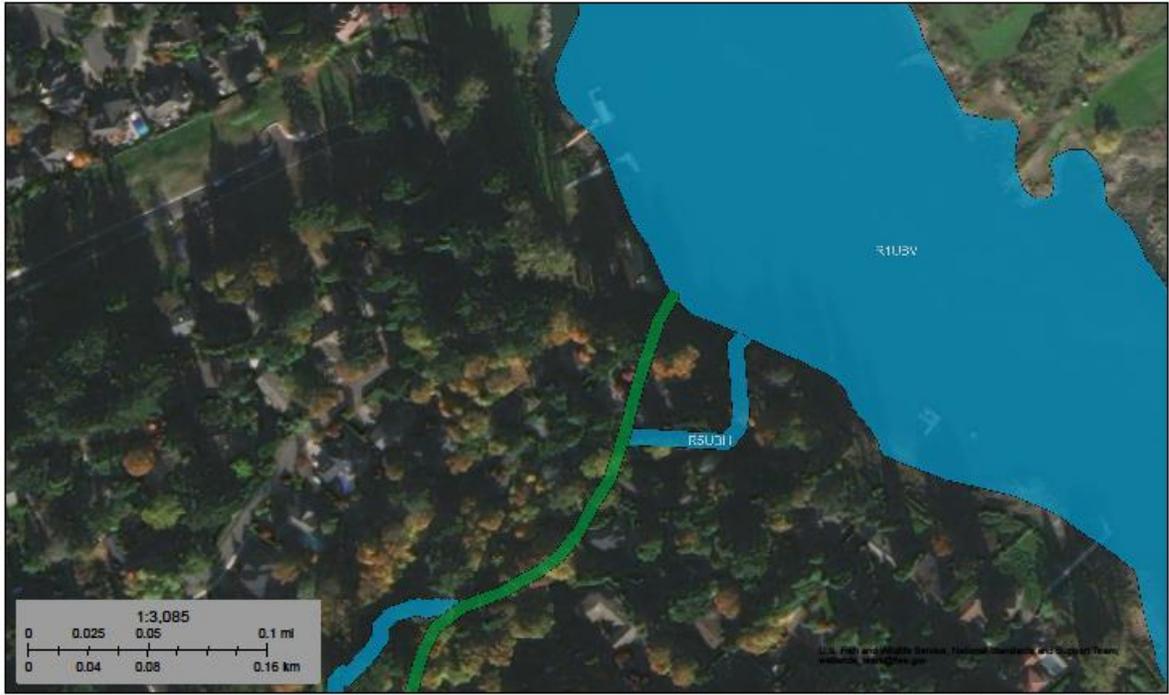
Figure 3b. National Wetlands Inventory Map.

The NWI lists a PFO1C Freshwater Forested/ Shrub Wetland approximately in the far eastern corner of the Site. Due to the unsafe conditions of the cliff and topographic constraints where the NWI contained a mapped wetland, DS-1 was as close as the investigation could allow for the initial site visit on May 25<sup>th</sup>, 2022. On August 18<sup>th</sup>, 2022, EMS conducted an additional field investigation to access the area the NWI mapped wetland was located. It was determined the area did not contain a wetland. See data determination forms in Appendix B.

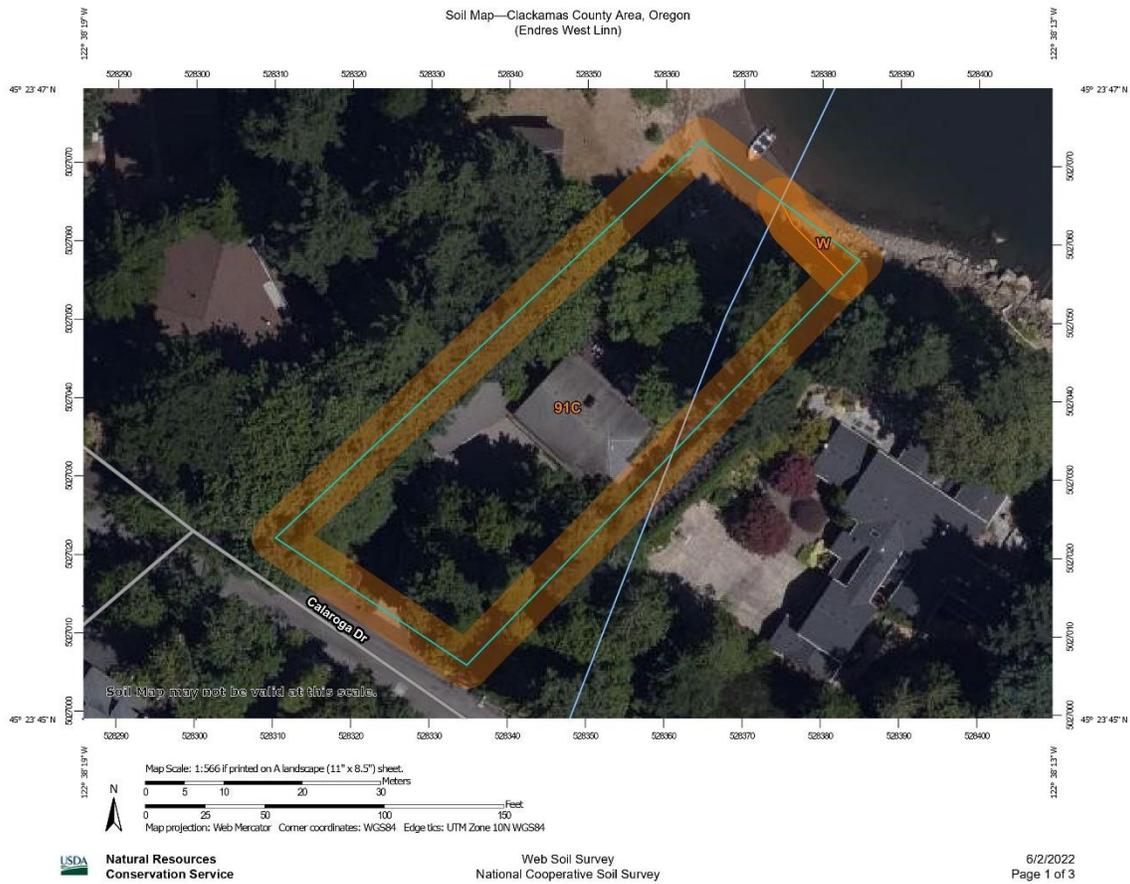
Figure 4a. Natural Resources Conservation Service (NRCS) Web Soil Survey Map.

Map Unit Symbol	Map Unit Name	Acres in AOI	Percent of AOI
91C	Woodburn silt loam, 8 to 15 percent slopes	0.5	98.9%
W	Water	0.0	1.1%
<b>Totals for Area of Interest</b>		<b>0.5</b>	<b>100.0%</b>

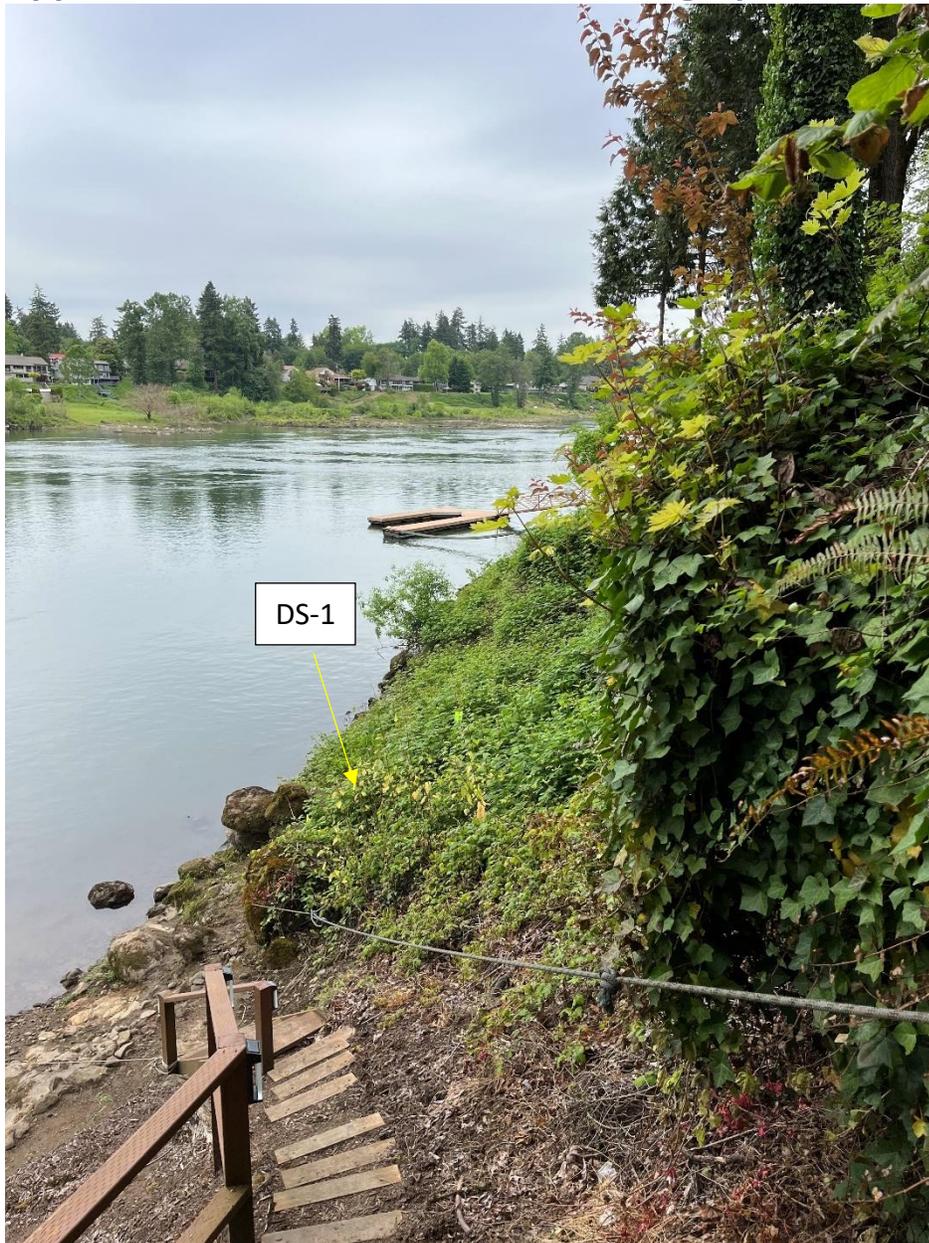
Figure 7a. Ground level photograph of cliff on Site between the house and Willamette River facing northeast; DS-1 is located within the toe slope between the cliff and the Willamette River. Flag presence is hard to spot due to vegetation growth. Note the boulders present.

All of the Data Sets DS-1, DS-2a, DS-2b, DS-3, and DS-4 documented upland conditions. Plot DS-1 contained soils that had a restrictive layer at 1 inch below grade, preventing identification of hydric soil indicators. Plot DS-1 contained hydrophytic vegetation dominated by *Rubus armeniacus* (FAC), *Populus balsamifera* (FAC), and *Hedera helix* (FACU) but was determined upland due to no wetland hydrology indicators and the inability to determine the presence of hydric soil indicators. DS-2a soils had a restrictive boulder/cobble layer and prevented soil analysis; the NRCS soil map listed 91C-Woodburn silt loam, 8 to 15 percent slopes, as hydric and wetland hydrology indicators were present. DS-2a was dominated by *Hedera helix* (FACU) and *Rubus armeniacus* (FAC) and determined to be non-hydrophytic, therefore it was determined to be upland. DS-2b was dominated by *Acer macrophyllum* (FACU), *Abies grandis* (FACU), *Hedera helix* (FACU), and *Polystichum munitum* (FACU). DS-2b had no hydric soil indicators and no wetland hydrology indicators, therefore it was determined to be upland.

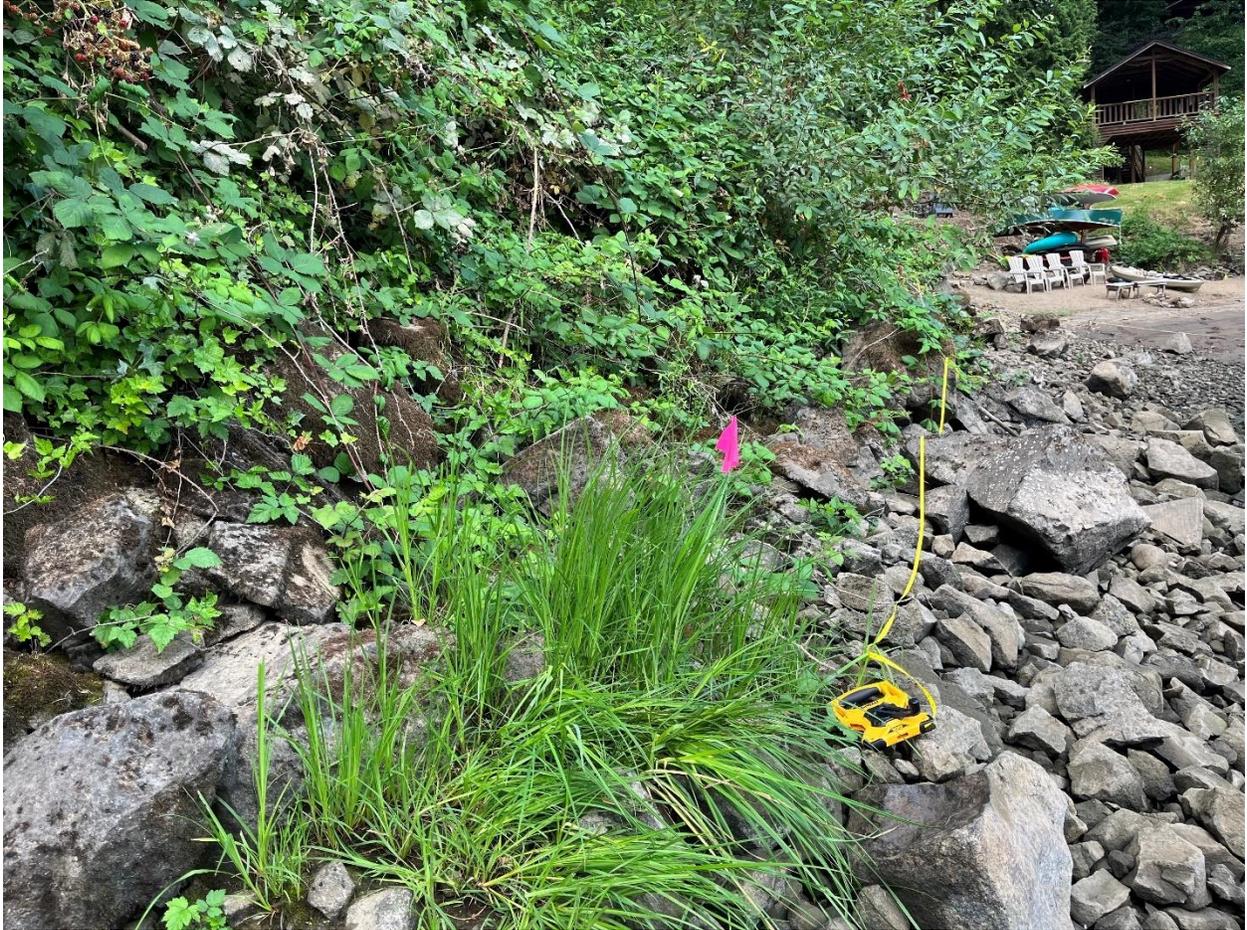
Figure 7b. Ground level photograph of DS-2a facing west.

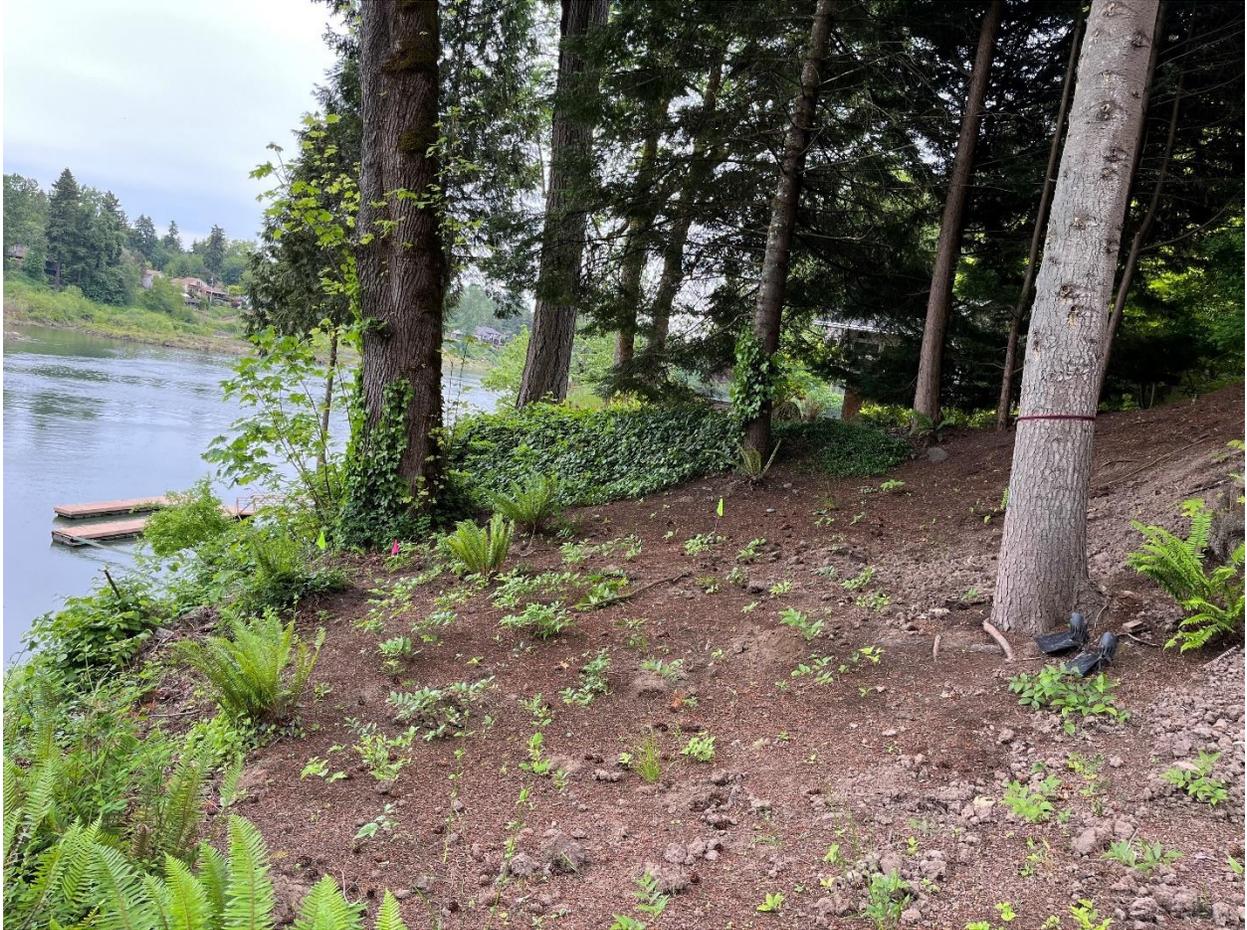
Figure 7c. Ground level photograph of DS-2b facing east.

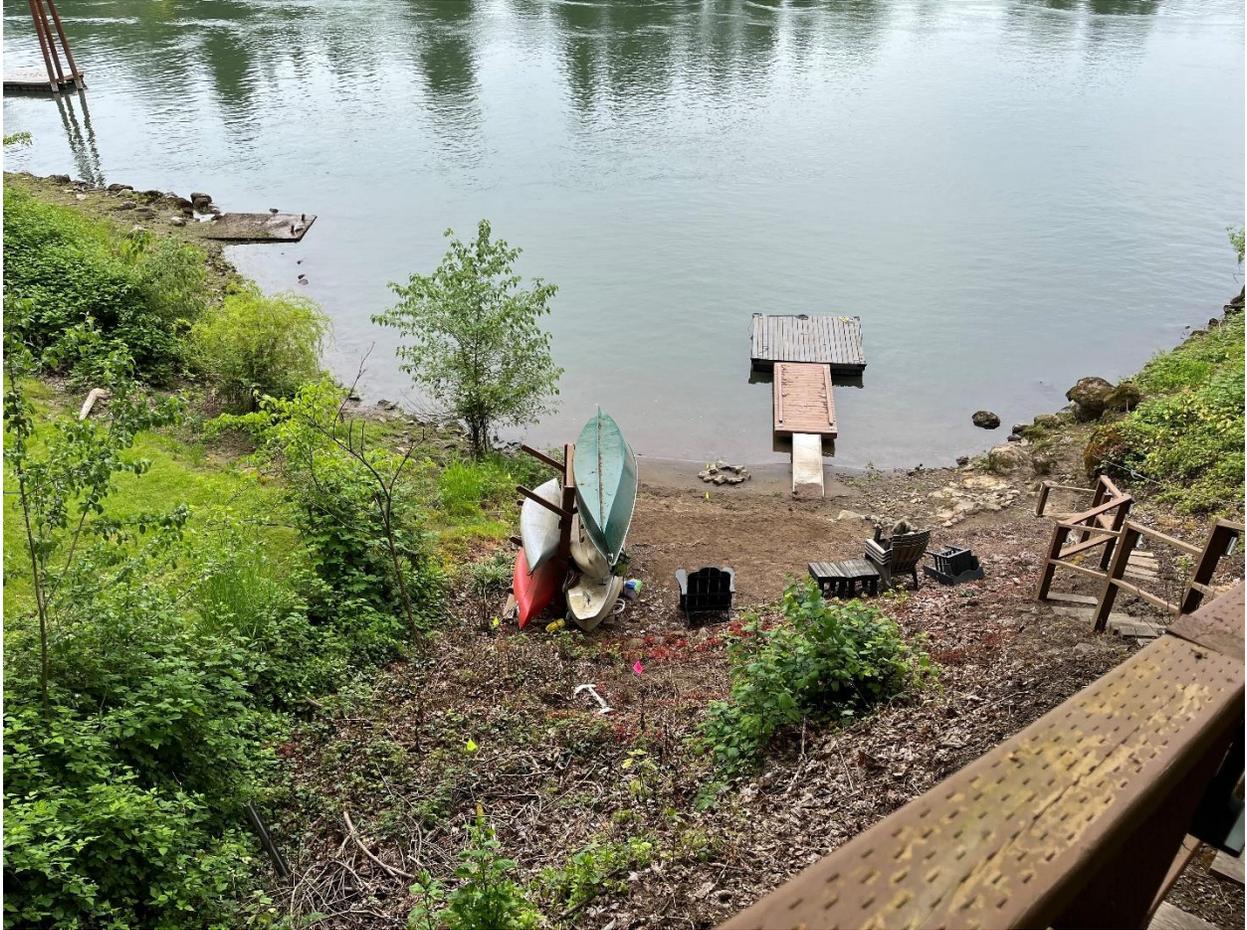
Figure 7d. Ground level photograph facing northeast of DS-3 (between the kayaks and the Willamette River) and DS-4 (between the kayaks and the stairway).

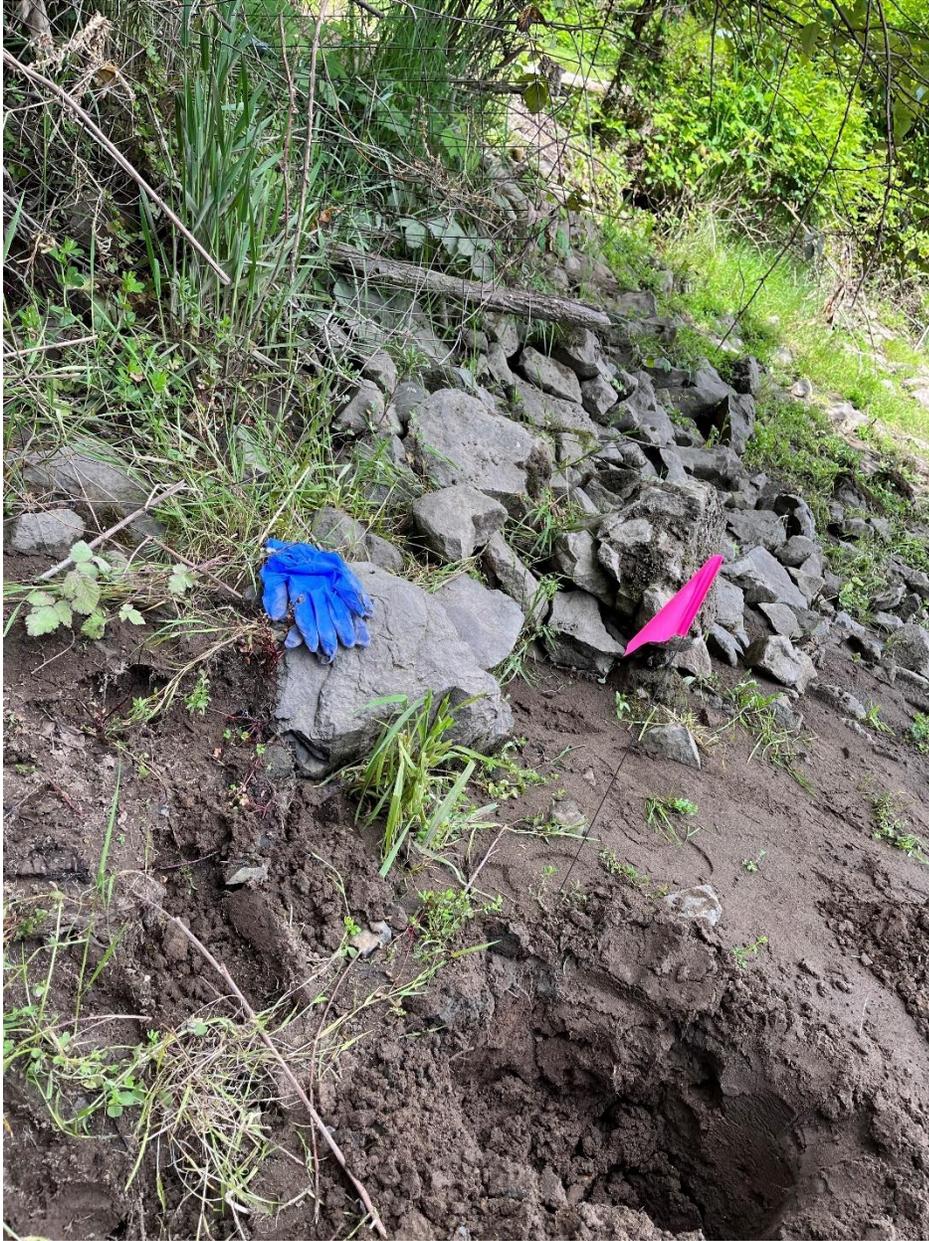
Figure 7e. Ground level photograph of DS-3 facing west.

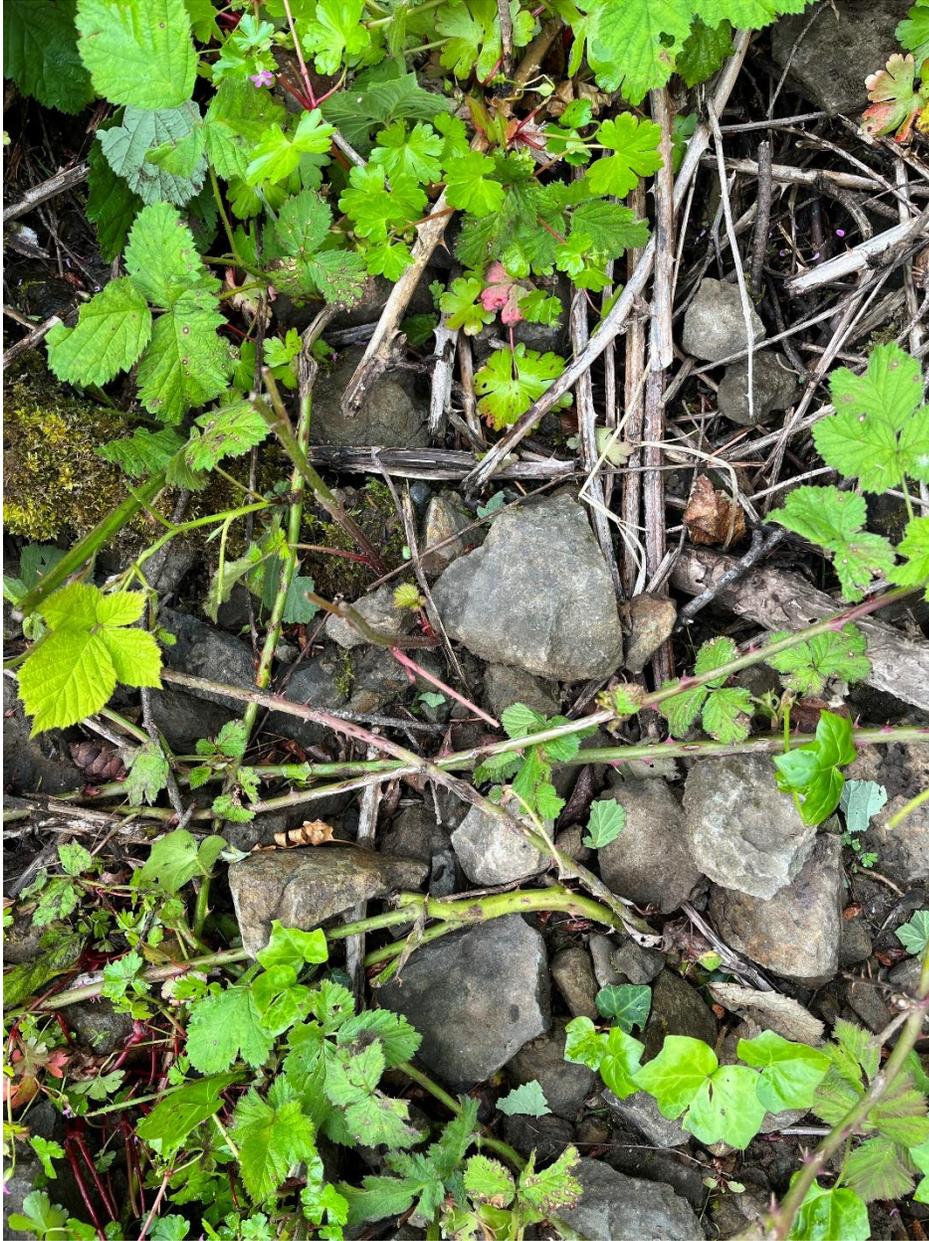
Figure 7f. Ground level photograph of restrictive soil layer at and adjacent to DS-1.

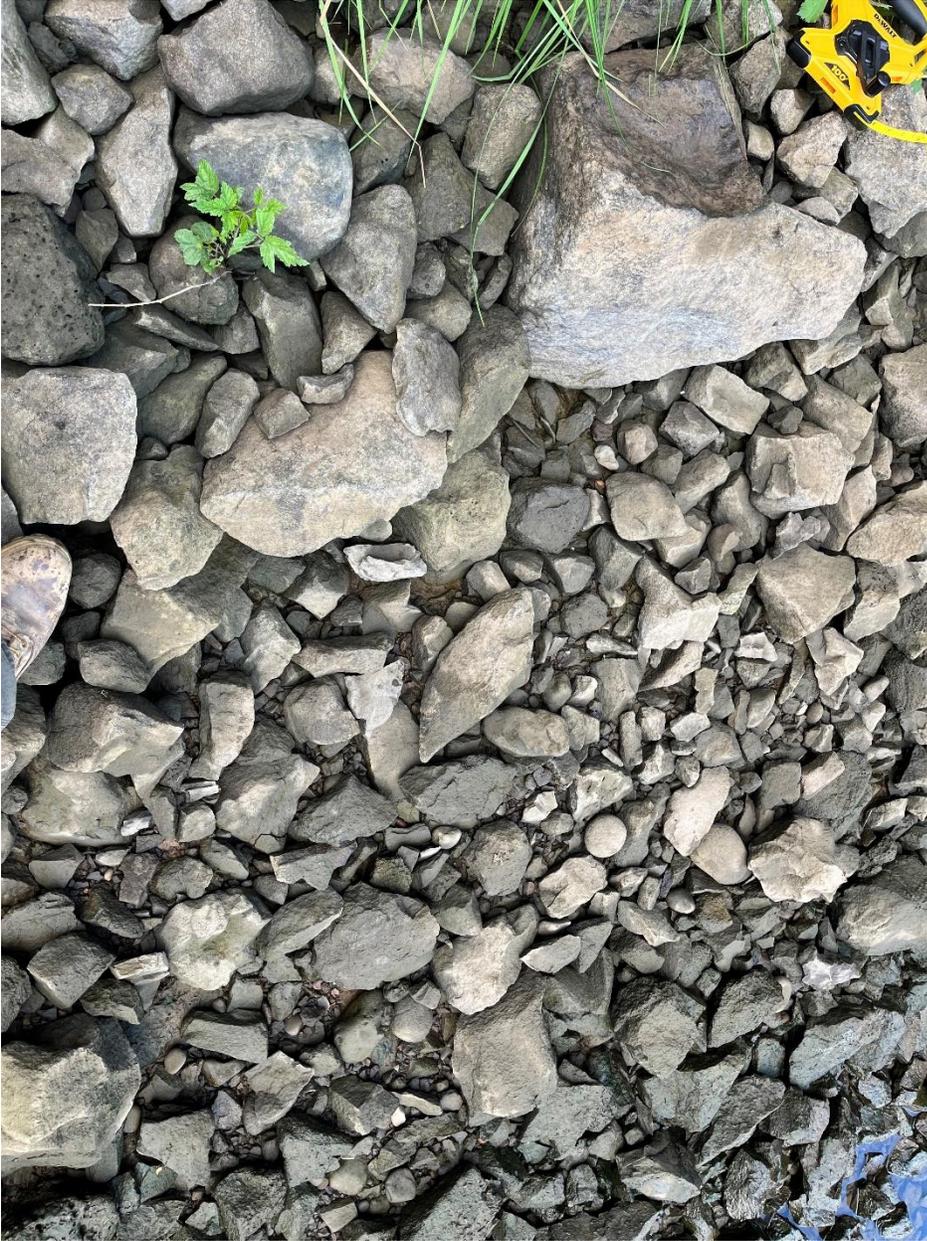
Figure 7g. Ground level photograph of restrictive soil layer at and adjacent to DS-2a.
